## **DAN RIVER COAL ASH SPILL**

**Senate Agriculture, Conservation and  
Natural Resources Committee**

**David K. Paylor  
February 27, 2014**

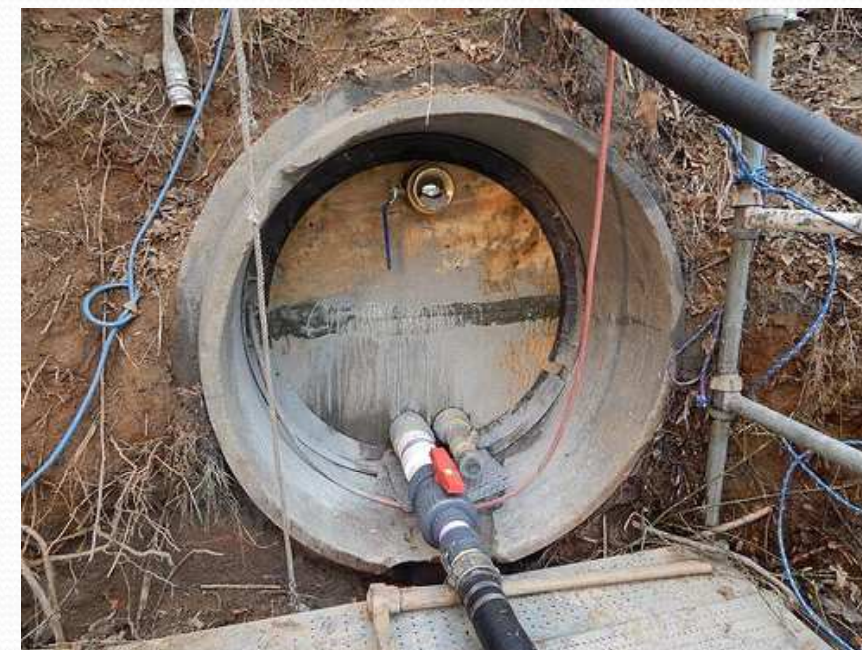
- Duke made several unsuccessful attempts to plug stormwater pipe; interim measures put in place at outfall to capture and contain discharge and pump back to a secondary ash basin.
- Saturday, 2/8 - Duke successfully installed grout plug in the last 27 feet of damaged storm water pipe; effectively stopped further discharge.

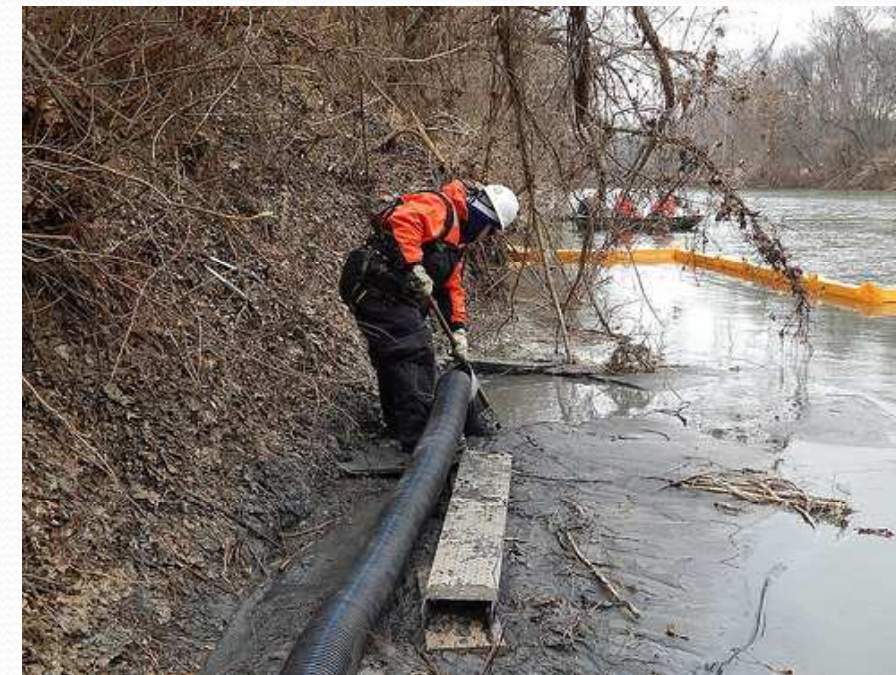
- Crews have begun recovering a large coal ash deposit from immediately below the discharge point
